CARBURETER INDEX AND PRICE LIST

CHEVROLET
1935-36-37-38

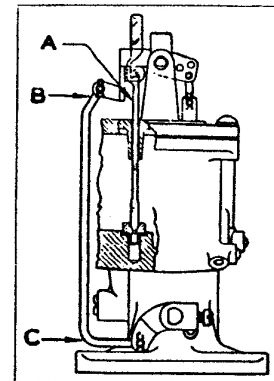
Metering rod adjustment: Back out throttle lever adjusting screw, insert gauge (Part No. T109-25) in place of metering rod, seating tapered end in metering rod jet. Hold gauge vertical to insure seating. Metering rod pin in pump arm should rest at bottom of notch in gauge (A) with throttle fully closed and upper end of connector rod (B) centering freely in hole in pump arm. If it does not, adjustment can be made by bending connector rod at (C), using tool No. T109-75.

Remove gauge, replace metering rod and disk and metering rod spring. Be sure metering rod is in jet. If metering rod shows wear, replace both metering rod and metering rod jet. Graphite grease should be put in hole in pump arm bracket before dust cover is replaced.
