CARBURETER INDEX AND PRICE LIST

**CHEVROLET
1932-33-34**

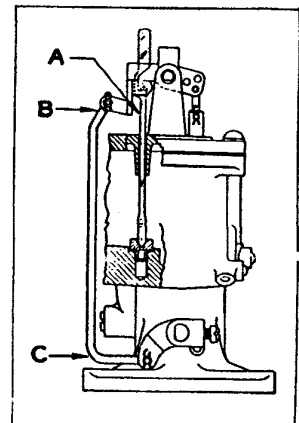
Figure shows 1934 Carburetor, No. 284S

Metering rod adjustment:
Back out throttle lever adjusting screw, insert gauge (Part No. T109-25) in place of metering rod, seating tapered end in metering rod jet. Hold gauge vertical to insure seating. Metering rod pin in pump arm should rest at bottom of notch in gauge (A) with throttle fully closed and upper end of connector rod (B) centering freely in hole in pump arm. If it does not, adjustment can be made by bending connector rod at (C), using tool No. T109-75.

Remove gauge, replace metering rod and disk and metering rod spring. Be sure metering rod is in jet. If metering rod shows wear, replace both metering rod and metering rod jet. Graphite grease should be put in hole in pump arm bracket before dust cover is replaced.
